Nondestructive Characterization of Impact Damage in Metallic/Nonmetallic Composites Using X-ray Computed Tomography Imaging

by William H. Green and Joseph M. Wells

ARL-TR-2399

February 2001

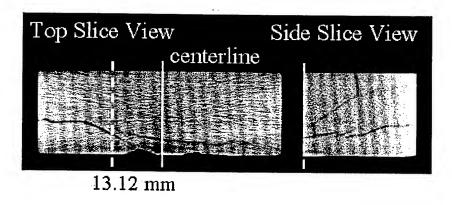
a. 15.61 mm from axis

Figures 7a, 7b, and 7c are top slice and front slice views with different front slice locations. The series of top slice and front slice views shows how damage perpendicular to the through thickness direction changes with distance from the impact face. Figures 8a, 8b, and 8c are top slice views with different side slice locations. The side slice locations in the figures are 15.61 mm, 13.12 mm, and 5.64 mm to the left of the axis of the piece, respectively. The series of side views shows how damage in the thickness direction changes with distance from the line of impact. Figures 9a, 9b, and 9c are 3-D solid visualizations showing different virtual sections. Figure 9b shows the piece with approximately one-third of it virtually cut off, while in Figure 9c approximately one-half is cut off. The sectioned surfaces appear as if the piece was actually cut at those surfaces. This is an excellent way to visualize damage while viewing the entire piece.

Figure 8. Top Slice and Side Slice Views With Different Side Slice Distances From Axis (Centerline).
